*iHomeInspect*Home Inspection Report

123 Main St, Anycity, ON Inspection prepared for: John Smith Date of Inspection: 6/1/2025

Inspector: Svetoslav Savov Phone: 647-869-3440 Email: getihomeinspect@outlook.com

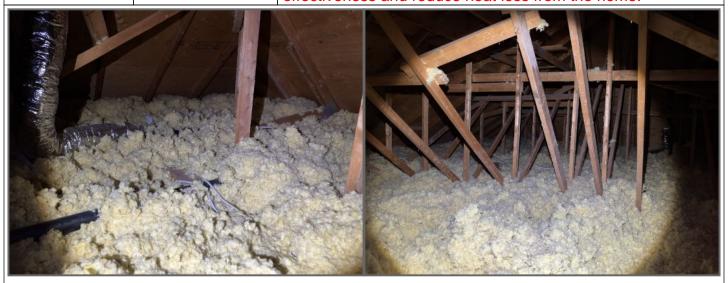
Page 11 Item: 7

• Disturbed insulation was noted. Recommend leveling out the insulation in the affected areas to optimize insulation effectiveness and reduce heat loss from the home.

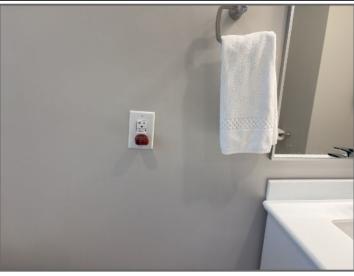
Page 22 Item: 6

- Outlet apparently inoperable in primary bathroom.
- Have a qualified electrician repair and complete evaluation of the electrical system.

Primary bathroom outlet doesn't operated.

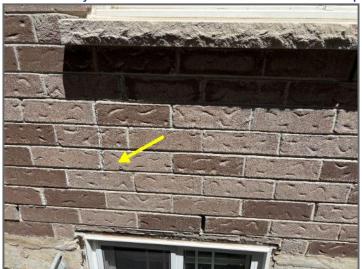
Minor wall crack noted.

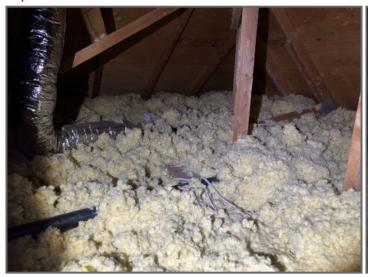
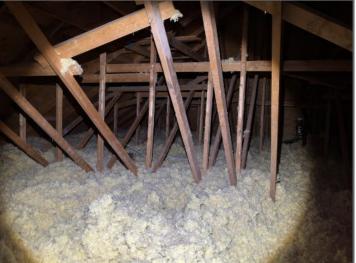
7. Insulation Condition

• Disturbed insulation was noted. Recommend leveling out the insulation in the affected areas to optimize insulation effectiveness and reduce heat loss from the home.

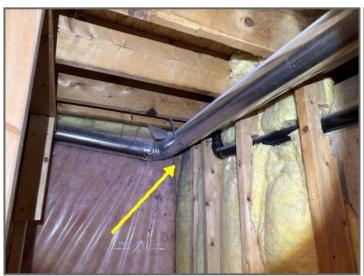
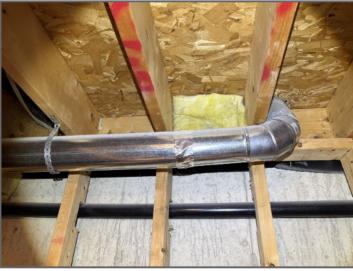
9. Dryer vent condition

- The dryer vent pipe is too long. This should be replaced due to the fact that lint can accumulate and catch fire.
- SAFETY INFO: One of the reason that restrictions are a fire hazard is that, along with water vapor evaporated out of wet clothes, the exhaust stream carries lint highly flammable particles of clothing made of cotton and polyester. Lint can accumulates in an exhaust duct, reducing the dryers ability to expel heated water vapor, which then accumulates as heat energy within the machine. As the dryer overheads, mechanical failures can trigger sparks, which can cause lint trapped in the dryer vent to burst into flames. This condition can cause the whole house to burst into flames!

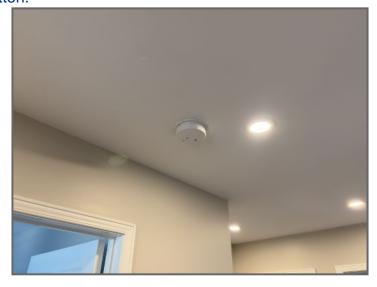
10. Smoke Detectors

- **CARBON MONOXIDE DETECTORS**
- IMPROVE: There was no visible CO (Carbon Monoxide) detector(s) in the home. The Consumer Product Safety Commission recommends that every residence with fuel-burning (gas) appliances be equipped with a UL Listed CO alarm. CO is colorless and odorless and thus impossible to detect without a proper electronic detector. At a minimum, put an alarm near the sleeping rooms on each level in your home. For the most trouble-free operation, I recommend the plug-in type -- not the battery operated type -- with digital readout that tells you the peak CO concentration whenever you push the peak level button.

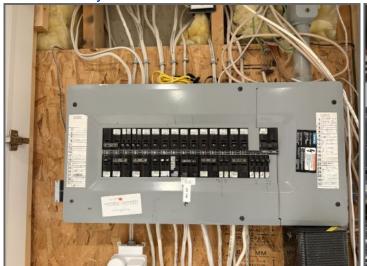
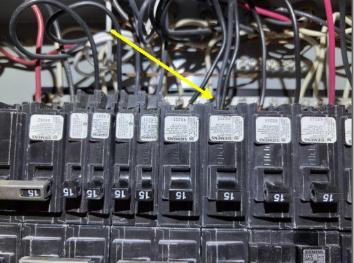
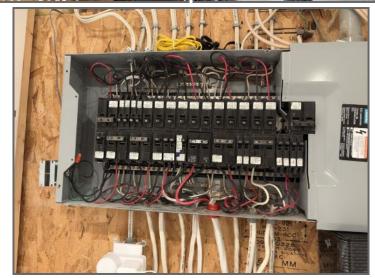
2. SERVICE PANEL

- Modern breaker distribution panel noted.
- Service size: 100 amps (240 Volts) Service size is determined by the main disconnect breaker.
- Double tapped breaker(s) inside panel box (more than one electrical conductor attached). This is not standard practice, and may cause overheating or even an electrical fire. Recommend evaluation by an electrician.

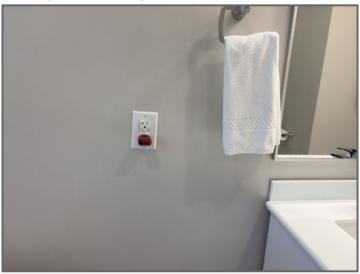
6. OUTLETS

- Outlet apparently inoperable in primary bathroom.
- Have a qualified electrician repair and complete evaluation of the electrical system.

Primary bathroom outlet doesn't operated.
